UNITED STATES ENVIRONMENTAL PROTECTION AGENCY
Region I - EPA New England

DATE: May 4, 2010

SUBJ: First Light Power Resources, Inc., Mt. Tom Generating Station
NPDES Permit No. MA0005339
NPDES Compliance Inspection Conducted 4/15/10

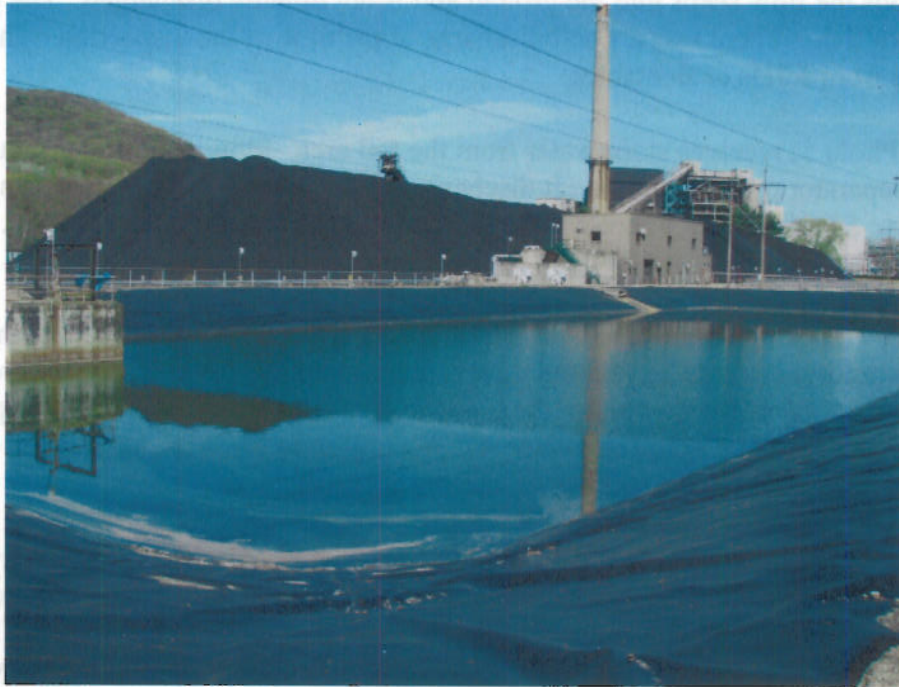
Photo 1 – View across Special Basin toward Treatment Building

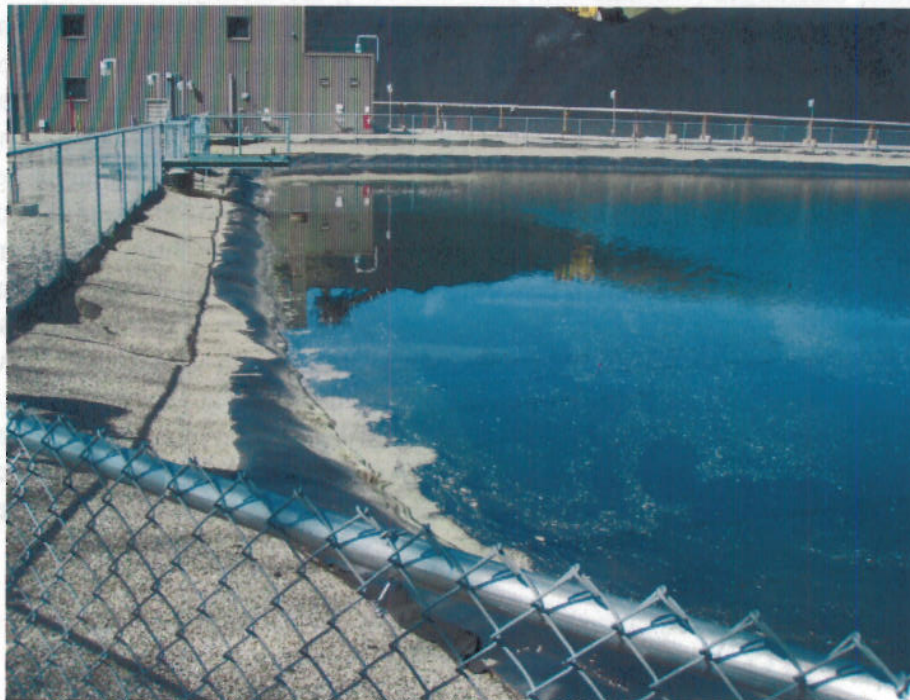
Photo 2 – View of outlet from Sedimentation Basin

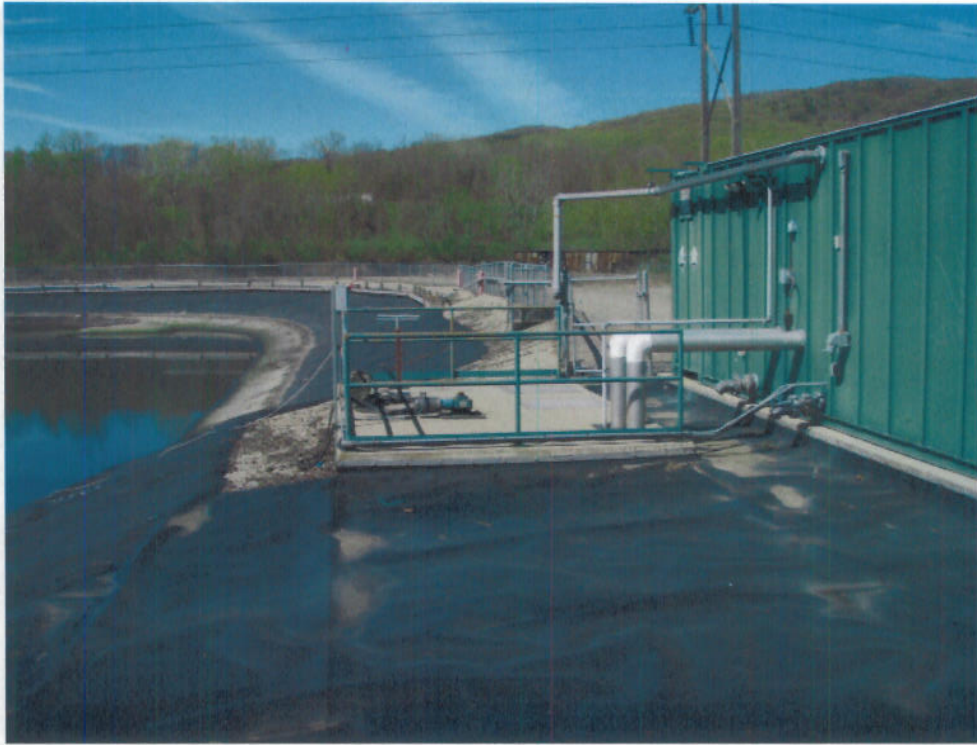
Outfalls 8 and 9 discharge treated bottom ash transport water. The pH of the incoming wastewater is adjusted (Photo 3), and the flow is discharged to a lined lagoon where the solids settle out. At the time of the inspection the lagoon was being drained down for inspection, and accumulated ash was being removed (Photo 4). According to Mr. Merchant this is done every year or two. The ash is sold for making decorative concrete.

Photo 3 – pH adjustment system at Bottom Ash Lagoon

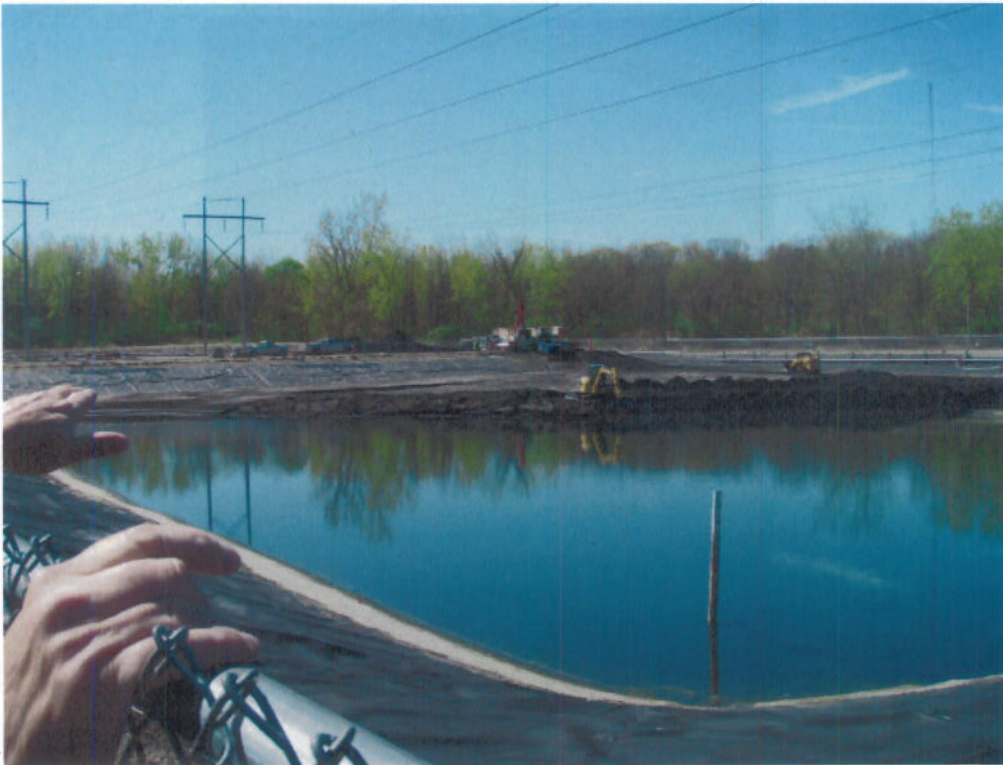
Photo 4 – Ash being removed from Bottom Ash Lagoon

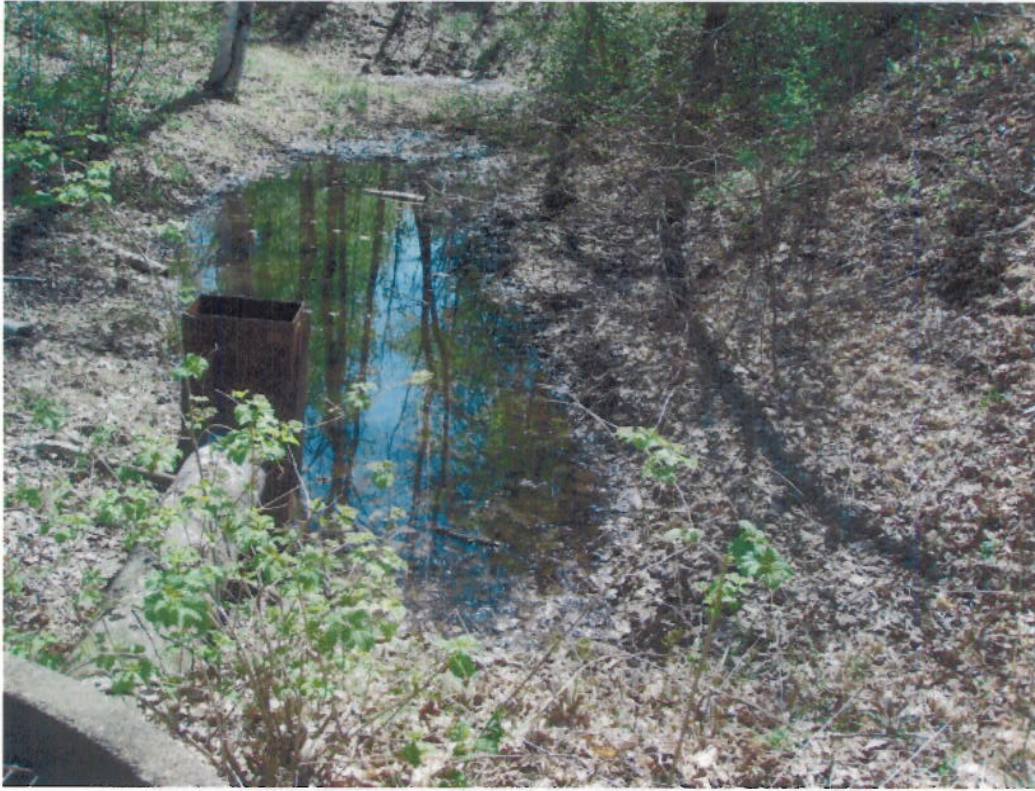
Outfall 007 (Photo 5) receives stormwater from the rail area. Flow goes into a small basin with an oil/water separator outlet structure. It discharges into a culvert that brings storm drainage from US Route 5 to the river. There was no discharge at the time of the inspection. No sheen was visible on the standing water in the basin.

Photo 5 – SW Basin and outlet at Outfall 007

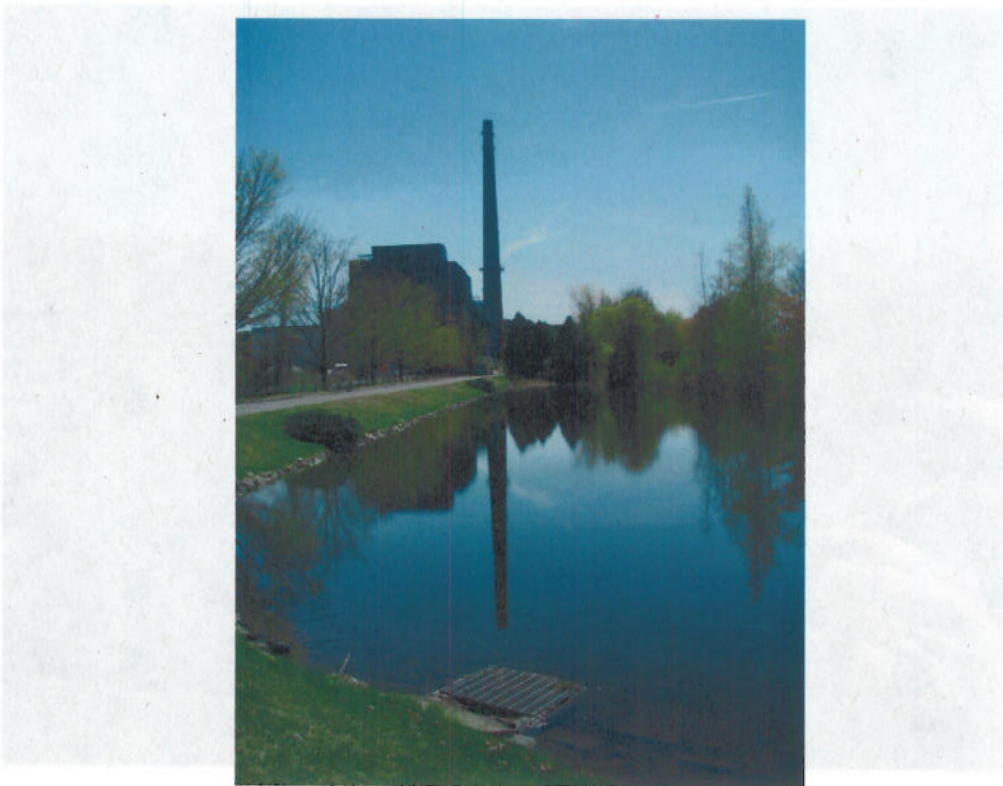
Outfall 006 (Photo 6) is the discharge from a decorative reflecting pond near the entrance to the plant. It is fed by runoff from the plant entrance road, overflow from a plant service water tank, and pump seal water. The discharge flows through a wooded area toward the river. During dry weather periods the flow seeps into the ground and is not directly discharged. The pond supports a population of fish. There was a small discharge at the time of the inspection. The water was clear and free from solids or floatables.

Photo 6 – Outlet to Reflecting Pond, Outfall 006

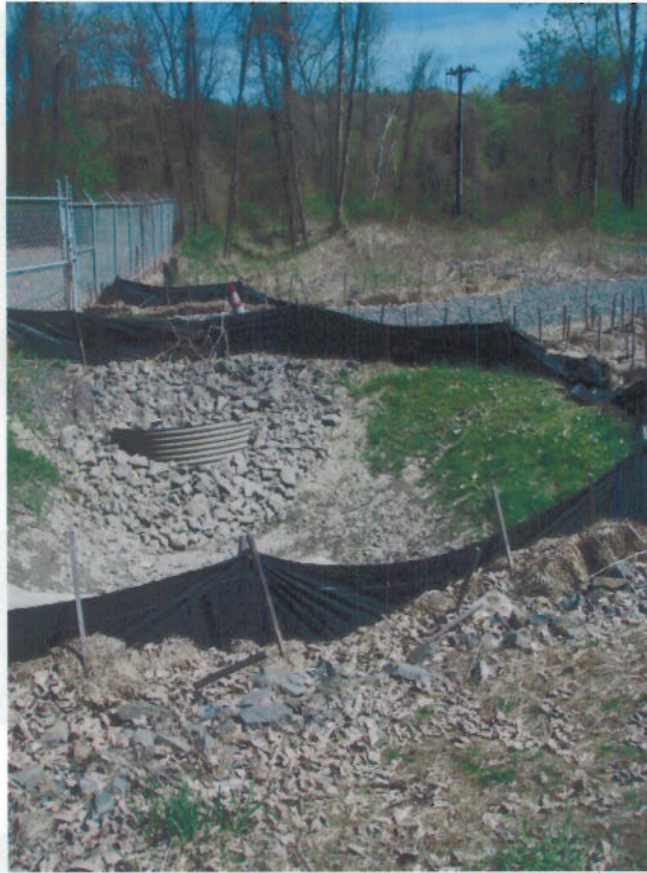
Outfall 004 discharges storm water from an area to the north of the generating unit. As with the other stormwater discharges (Outfalls 003, 004, and 007), the facility's NPDES permit included limits on total suspended solids (TSS) of 30 mg/ monthly average, 100 mg/l maximum day. These limits were established based on best professional judgment. In late 2008 through mid 2009 the facility conducted construction operations in the area tributary to this outfall, including installation of a new septic system, removal of an old oil tank, and construction of new air pollution removal equipment. Stormwater controls such as silt fences and hay bales were installed; but during heavy rains in October 2008 severe violations of the permit occurred. The facility notified EPA of these violations, and based on the recommendations of its engineer added additional storm water controls, such as covering disturbed areas with filter fabric and stone and adding additional layers of sit fence and hay bales along the length of the drainage swale (Photos 7, 10 & 11). Despite these additional measures the violations continued during heavy rains through May 2009, when the facility diverted all flow to an adjacent gravel parking area where it is allowed to evaporate (Photos 8 & 9). The facility attributes the violations in large part to the presence of fine clay soils in the construction area. At the time of the inspection accumulations of fine particles were observed in the drainage swale, behind silt fences, and in the evaporation area. No visible accumulation of sediment was observed in the river (Photo 12).

Photo 7 – Drainage Swale at Outfall 004 showing some erosion control measures

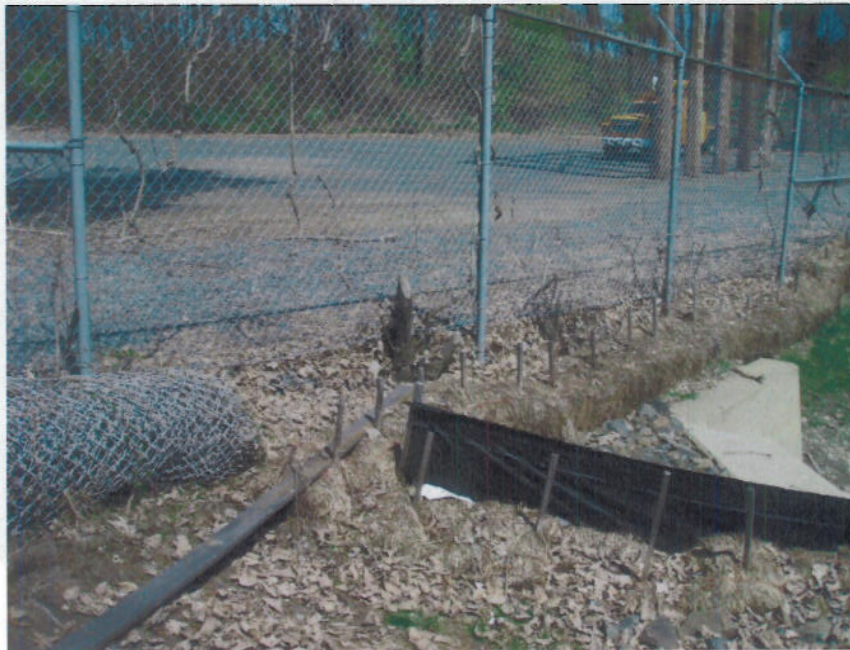
Photo 8 – Evaporation area – 004 flows are diverted here to prevent discharge to the river

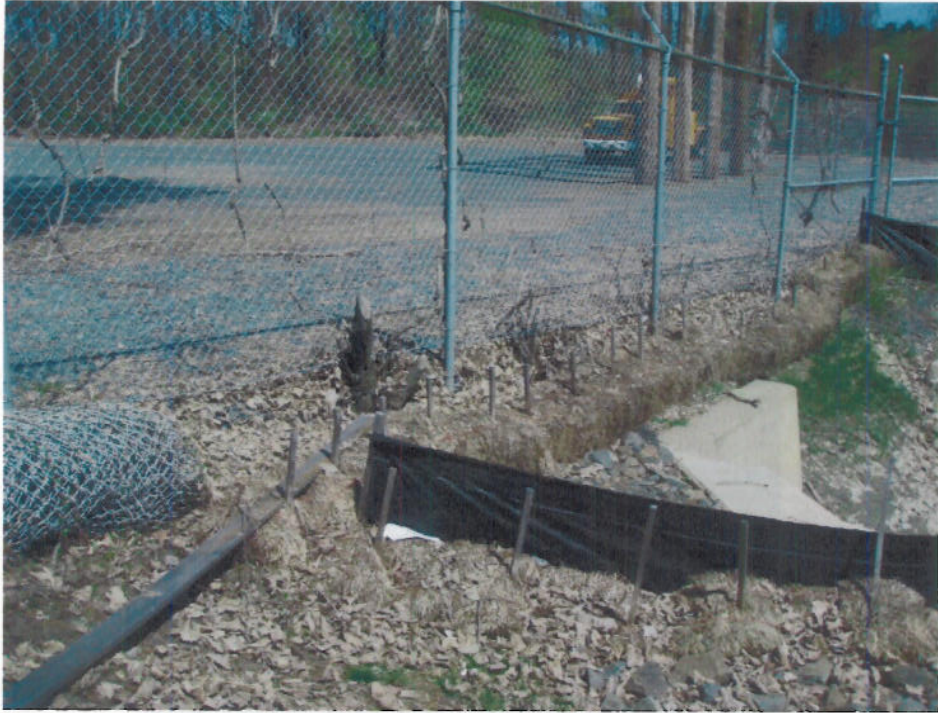
Photo 9 – Another view of the evaporation area

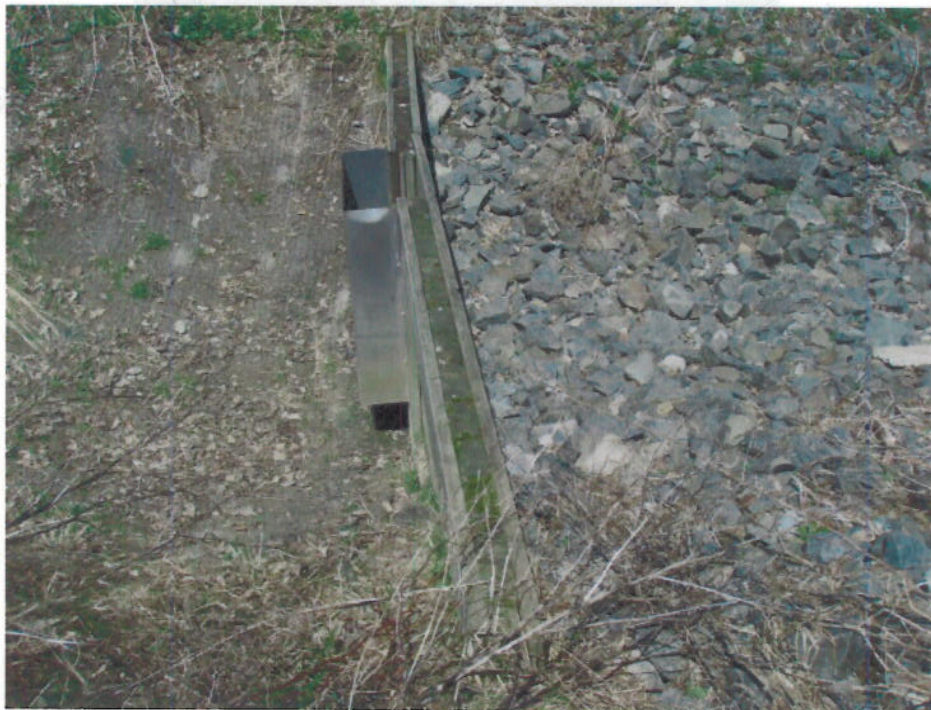
Photo 10 – Rock filter added to drainage swale at Outfall 004

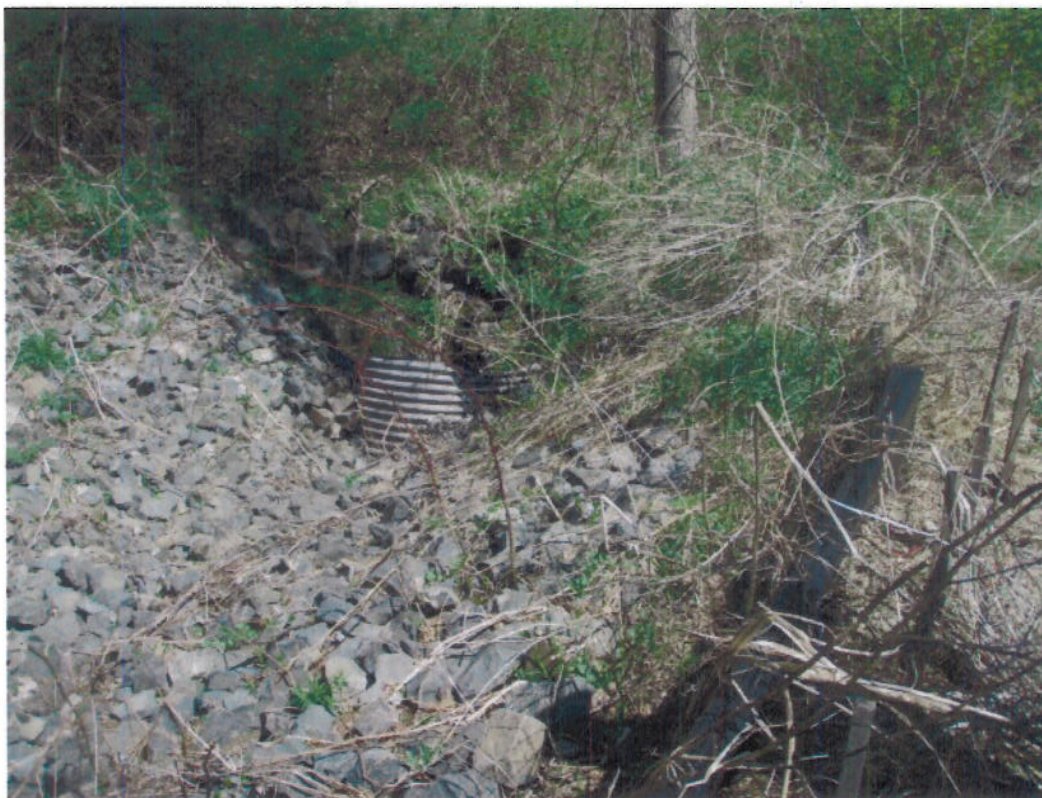
Photo 11 - Rock filter and baffle structure added to drainage swale at Outfall 004
